POS LV V5 Release Notes

Document # PUBS-CINS-004273

Revision: 35

Date: November 29, 2020

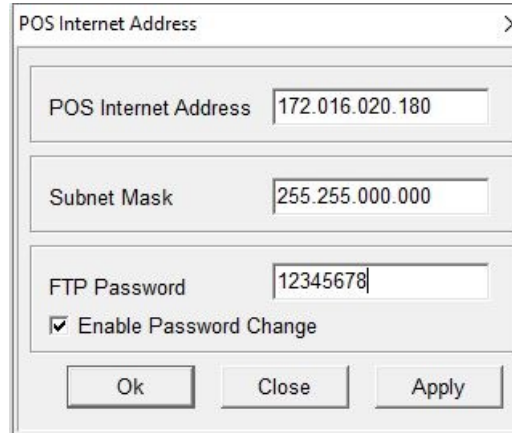
- **Added capability to set a custom FTP password**

The password for FTP access to POS LV, used to access backup logged data, can now be changed using POSView. To do so, go to Settings->Installation->POS IP Address and check “Enable Password Change”.

Once this box is checked a new FTP password may be entered. Click apply to make the change. The password must be between 4 and 8 characters long, and may include upper and lower case letters or numbers only.
